Pentium® Pro Processor Specification Update

Release Date: August 1997

Order Number: 242689-020

The Pentium® Pro processor may contain design defects or errors known as errata which may cause the product to deviate from published specifications. Current characterized errata are documented in this Specification Update.

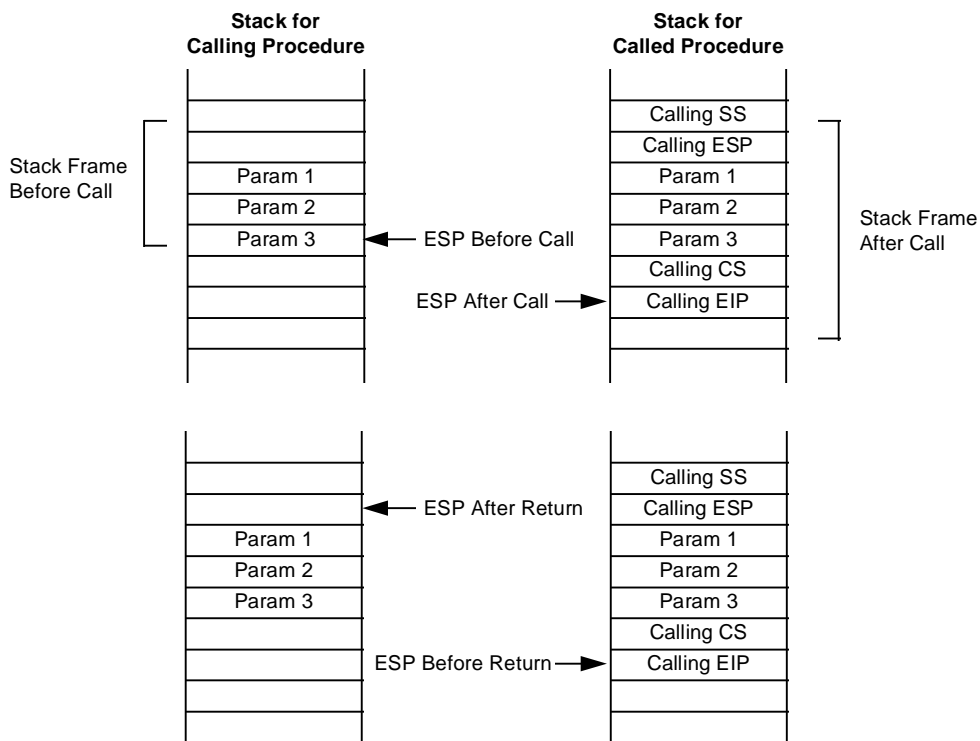
Figure 4-3. Stack Switch on a Call to a Different Privilege Level

Note: On a return, parameters are released on both stacks if the correct value is given for the *n* operand in the RET *n* instruction.

When making a call to a more privileged protection level, the processor does the following (see Figure 4-3):

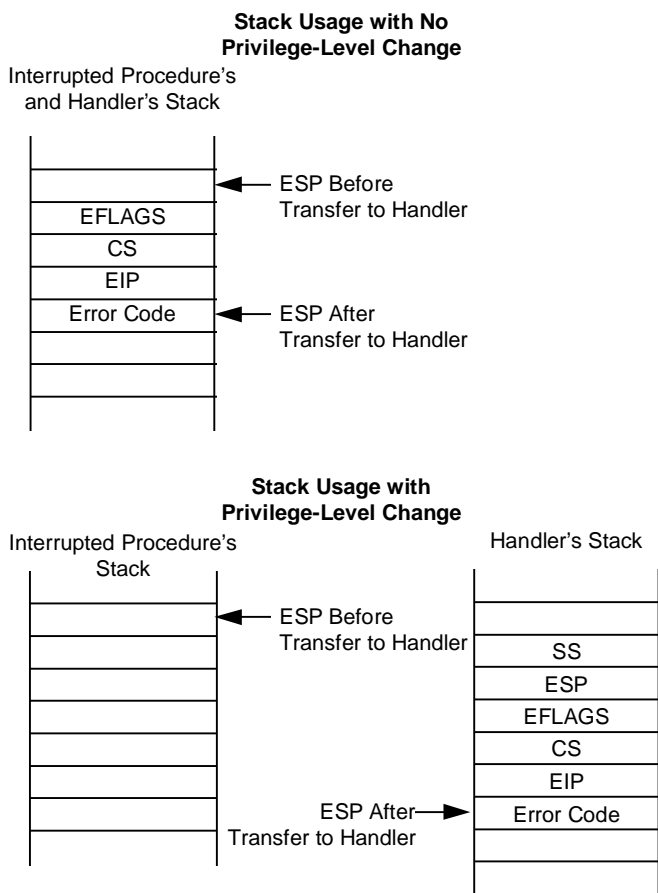
Figure 4-4. Stack Usage on Transfers to Interrupt and Exception Handling Routines

When executing a return from an interrupt or exception handler from a different privilege level than the interrupted procedure, the processor performs these actions:

1. Performs a privilege check.
2. Restores the CS and EIP registers to their values prior to the interrupt or exception.
3. Restores the EFLAGS register.
4. Restores the SS and ESP registers to their values prior to the interrupt or exception, resulting in a stack switch back to the stack of the interrupted procedure.
5. Resumes execution of the interrupted procedure.
